YOUR ONESURVEY  
**HOME REPORT**

The Lodge House  
301 Albert Drive  
Glasgow  
G41 5RP

# SINGLE SURVEY

<b>Selling address</b>	The Lodge House 301 Albert Drive Glasgow G41 5RP
------------------------	---

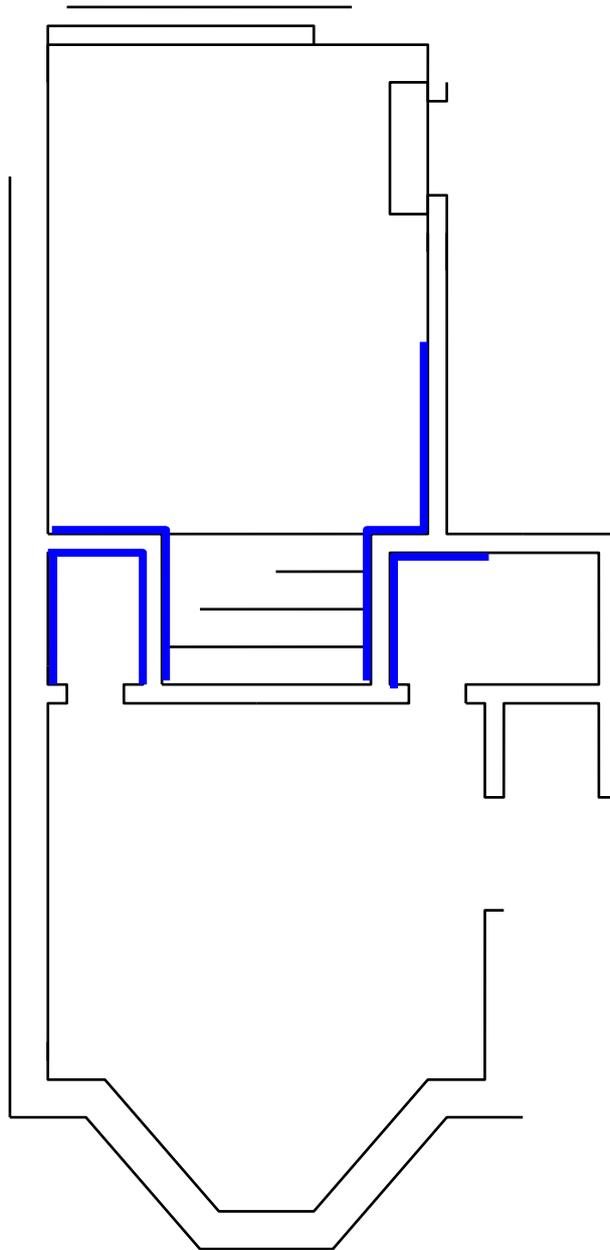
Part Ground Floor Plan

Notes:	Above average damp readings were obtained to localised sections of lower wall lining at ground floor level. A precautionary check of the entire property should be carried out by a reputable timber specialist prior to purchase.  It is understood that the property has been inspected by Rowallan (see attached report). These repairs should be carried out and covered by guarantee.

Chemical DPC
