# Energy Performance Certificate (EPC)

4 MILL LADE, BLYTH BRIDGE, WEST LINTON, EH46 7HY

# Single Survey

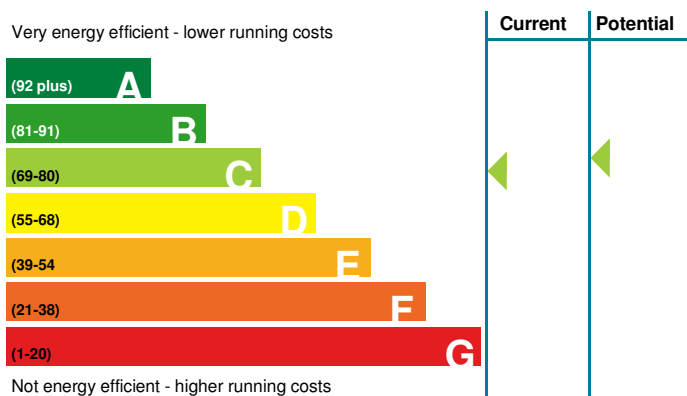
## Energy Efficiency Rating

This graph shows the current efficiency of your home, taking into account both energy efficiency and fuel costs. The higher this rating, the lower your fuel bills are likely to be.

Your current rating is **band C (74)**. The average rating for EPCs in Scotland is **band D (61)**.

The potential rating shows the effect of undertaking all of the improvement measures listed within your recommendations report.

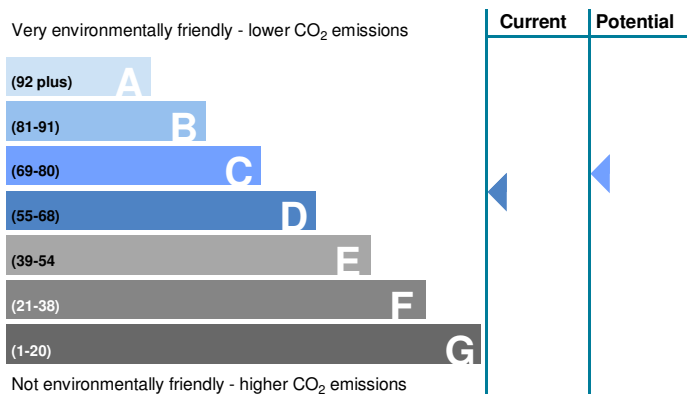
## Environmental Impact (CO<sub>2</sub>) Rating

This graph shows the effect of your home on the environment in terms of carbon dioxide (CO<sub>2</sub>) emissions. The higher the rating, the less impact it has on the environment.

Your current rating is **band D (68)**. The average rating for EPCs in Scotland is **band D (59)**.

The potential rating shows the effect of undertaking all of the improvement measures listed within your recommendations report.

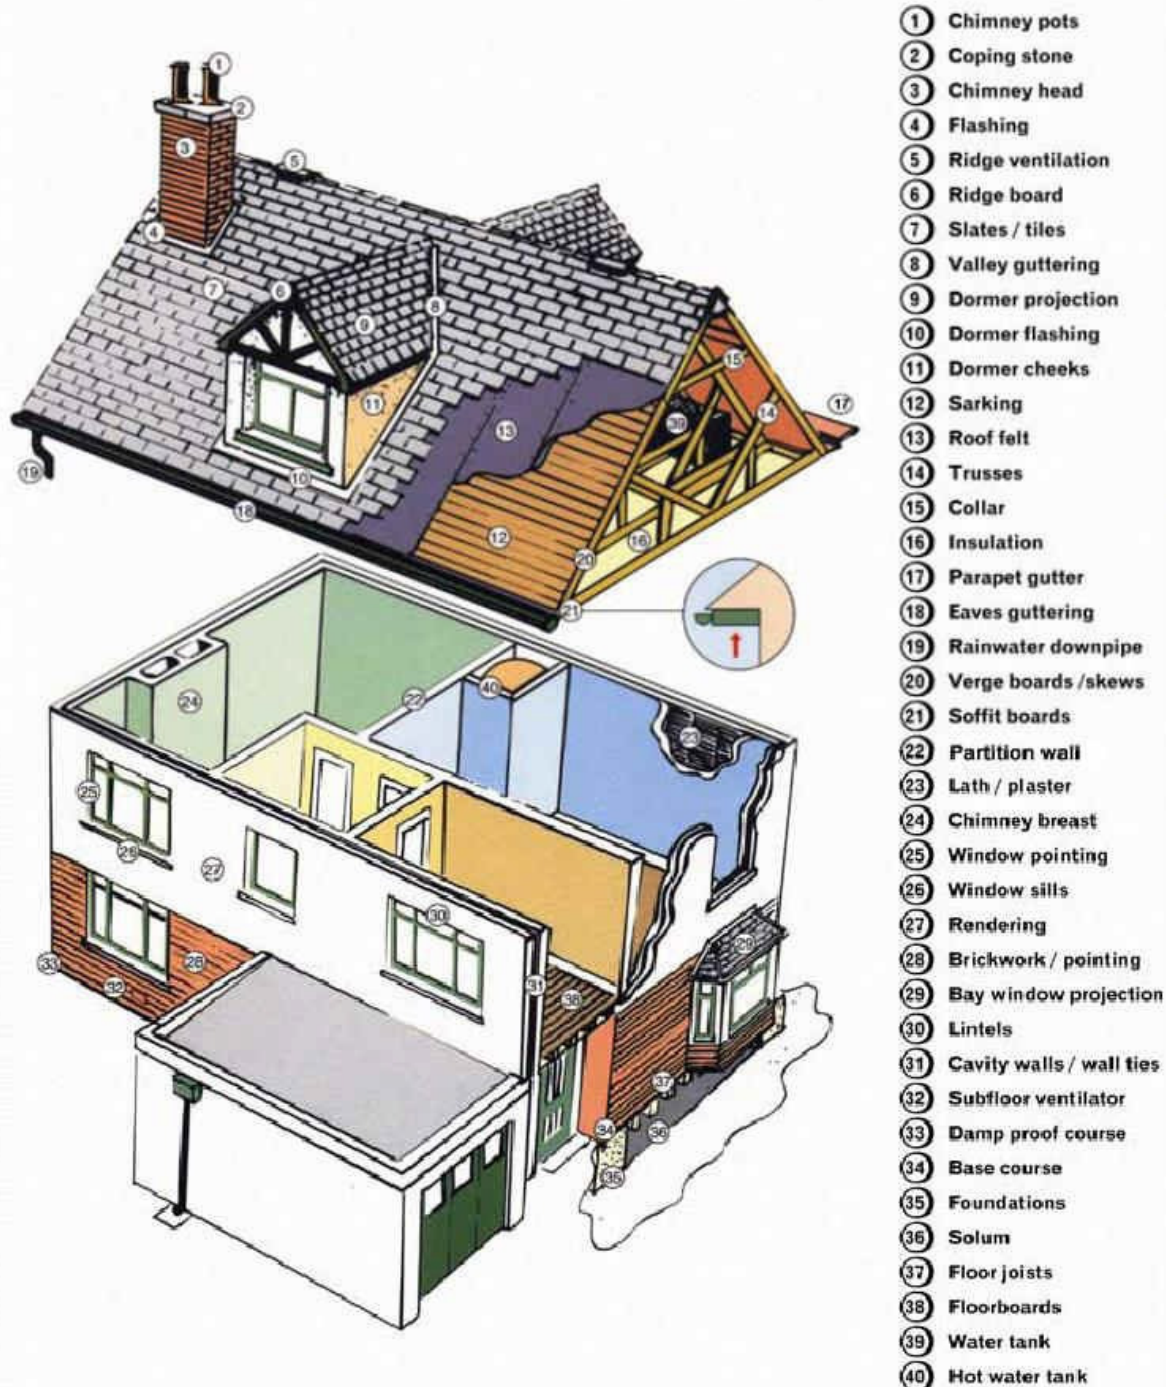
## Sectional Diagram showing elements of a typical house

Reference may be made in this report to some or all of the above component parts of the property. This diagram may assist you in locating and understanding these items.
