YOUR ONESURVEY  
**HOME REPORT**

0/2  
29 College Street  
Glasgow  
G1 1QH

| Document | Status | Prepared By | Prepared On |
|---|---|---|---|
| <u>Single Survey</u> | Final | Glasgow North - Allied Surveyors Scotland Plc | 03/11/2020 |

# Single Survey

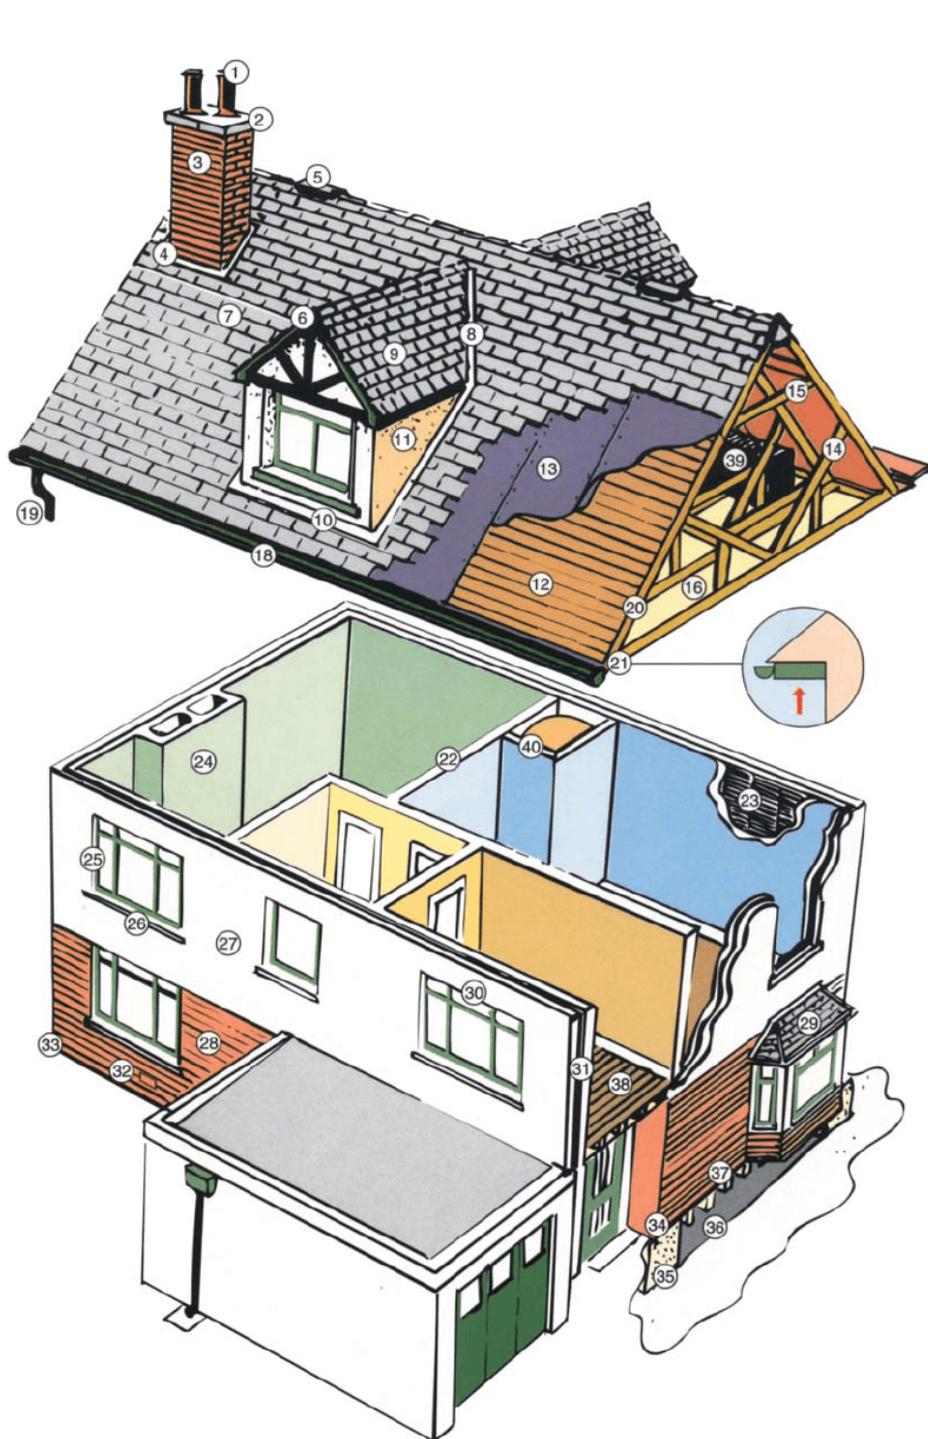
# Sectional Diagram showing elements of a typical house

- ① Chimney pots
- ② Coping stone
- ③ Chimney head
- ④ Flashing
- ⑤ Ridge ventilation
- ⑥ Ridge board
- ⑦ Slates / tiles
- ⑧ Valley guttering
- ⑨ Dormer projection
- ⑩ Dormer flashing
- ⑪ Dormer cheeks
- ⑫ Sarking
- ⑬ Roof felt
- ⑭ Trusses
- ⑮ Collar
- ⑯ Insulation
- ⑰ Parapet gutter
- ⑱ Eaves guttering
- ⑲ Rainwater downpipe
- ⑳ Verge boards /skews
- ㉑ Soffit boards
- ㉒ Partiton wall
- ㉓ Lath / plaster
- ㉔ Chimney breast
- ㉕ Window pointing
- ㉖ Window sills
- ㉗ Rendering
- ㉘ Brickwork / pointing
- ㉙ Bay window projection
- ㉚ Lintels
- ㉛ Cavity walls / wall ties
- ㉜ Subfloor ventilator
- ㉝ Damp proof course
- ㉞ Base course
- ㉟ Foundations
- ㊱ Solum
- ㊲ Floor joists
- ㊳ Floorboards
- ㊴ Water tank
- ㊵ Hot water tank

Reference may be made in this report to some or all of the above component parts of the property. This diagram may assist you in locating and understanding these items.
